Manhole Inspection Summary

Manhole # S31CC2004MH

Insp Date: **12/6/06 10:45 AM**

Location Address: **202 CHURCHWARDENS RD** Cross Street: **ENDERLY RD**

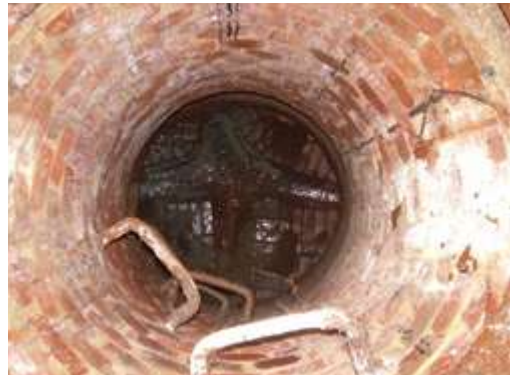
Top View

Corroded steps. Bench debris.

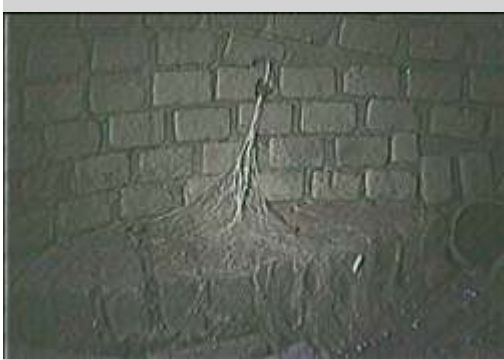
Defect

Barrel root intrusion and infiltration.

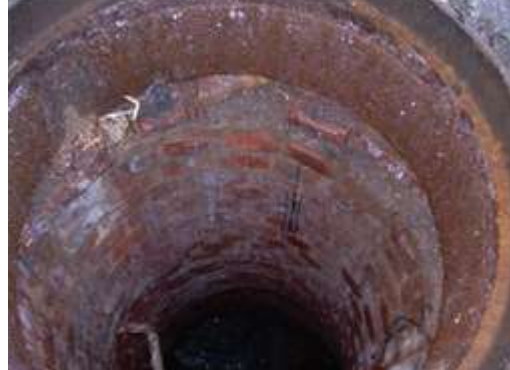
Defect

Frame leaks. Frame offset. Adjustment deterioration and infiltration.

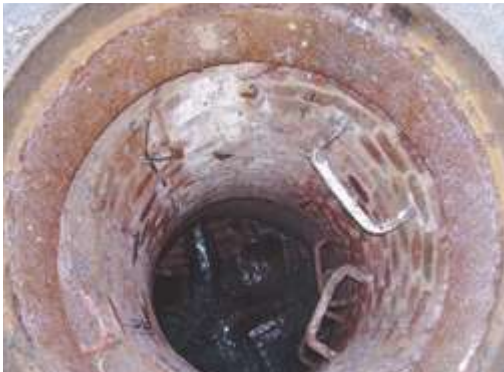
Defect

Adjustment deterioration and infiltration.

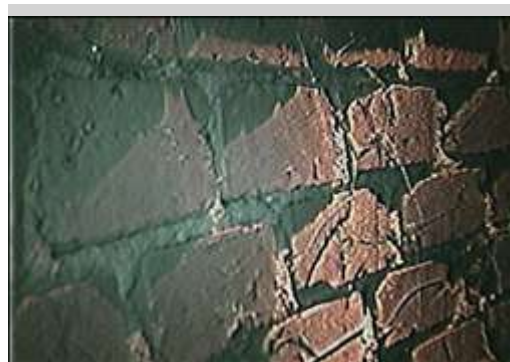
Defect

Corbel root intrusion and infiltration..

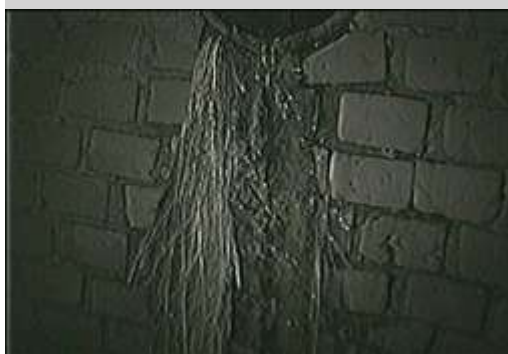
Defect

Barrel root intrusion.

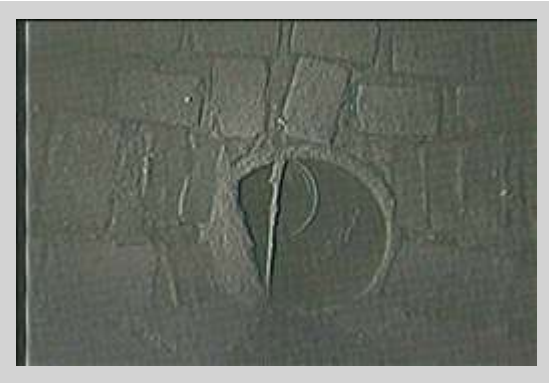
Pipe Out @ 12 O'Clock

Infiltration: **Evidence** Pipe Seal Cond: **Roots**

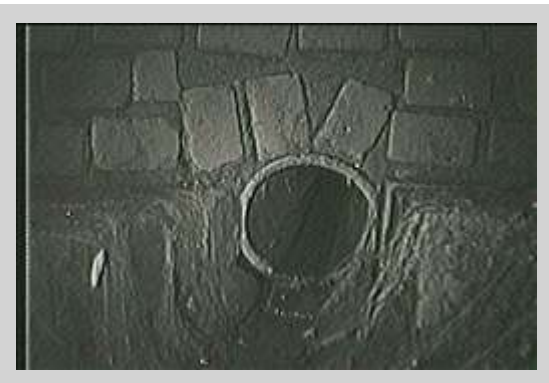
Pipe In @ 3 O'Clock

Infiltration: **Evidence** Pipe Seal Cond: **Unknown**

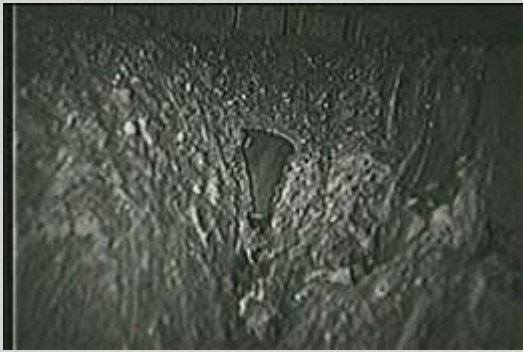
Pipe In @ 6 O'Clock

Channel root intrusion.

Deposits: ☐ None ☒ **Mud** ☐ Sludge ☐ Debris ☒ **Grease**

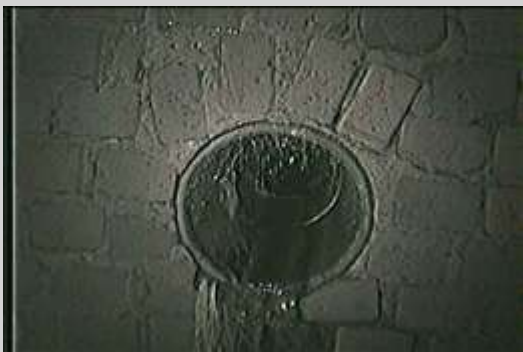
Pipe In @ 9 O'Clock

Infiltration: **Evidence**

Pipe Seal Cond: **Roots**

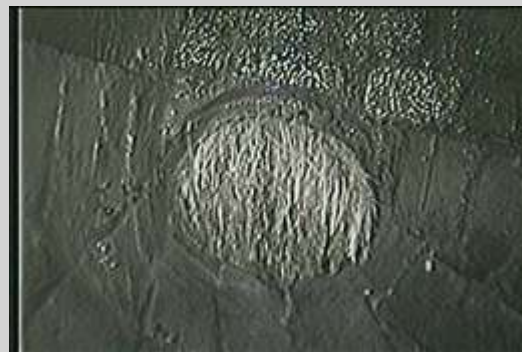
Drop In @ 9 O'Clock

Root Intrusion filled Pipe

Drop Condition: **Clogged**
